Engine Division

SUBJECT: Prestolite Distributor Housing - Excessive Moisture
and Rust Build-Up

MODEL(S) AFFECTED: All V-8 Gasoline Engines

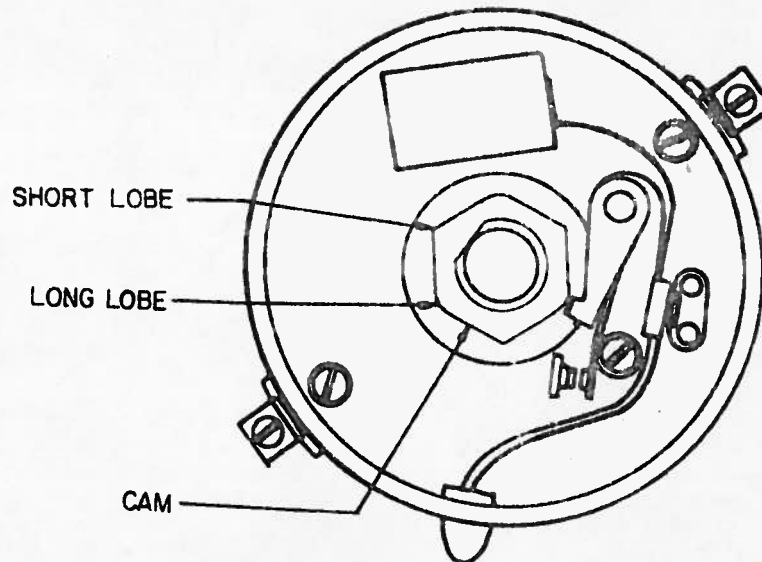
(FIG. 1)

LEFT HAND ROTATION (AUTO)

1. Set engine timing (#1 cylinder) at T.D.C. static. Note: Make sure cylinder is on power stroke.
2. Install distributor with rotor at 12 o'clock position, as looking at engine from rear.
3. Rotate distributor housing so breaker points open on long lobe of distributor cam.
4. Set point gap at .020 inch.
5. Start engine, check dwell reading and adjust to specification 39° , set timing 10° B.T.D.C. Set idle speed as necessary to obtain 500 RPM in forward gear.

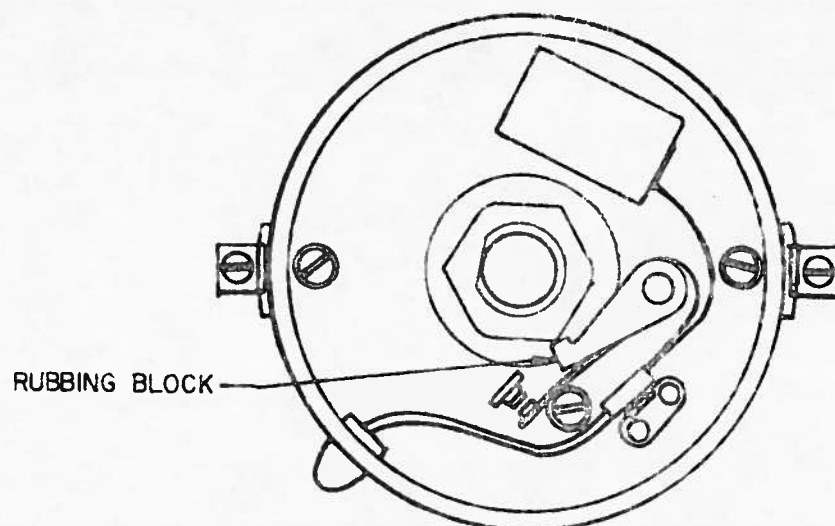
(FIG. 3)

LEFT HAND ROT. - LONG LOBE
RIGHT HAND ROT. - SHORT LOBE

RIGHT HAND ROTATION (OPPOSITE)

Procedure is the same as for left hand, except step No. 3. Set breaker point rubbing block on short cam lobe to set point gap. Set dwell and timing - adjust idle speed.

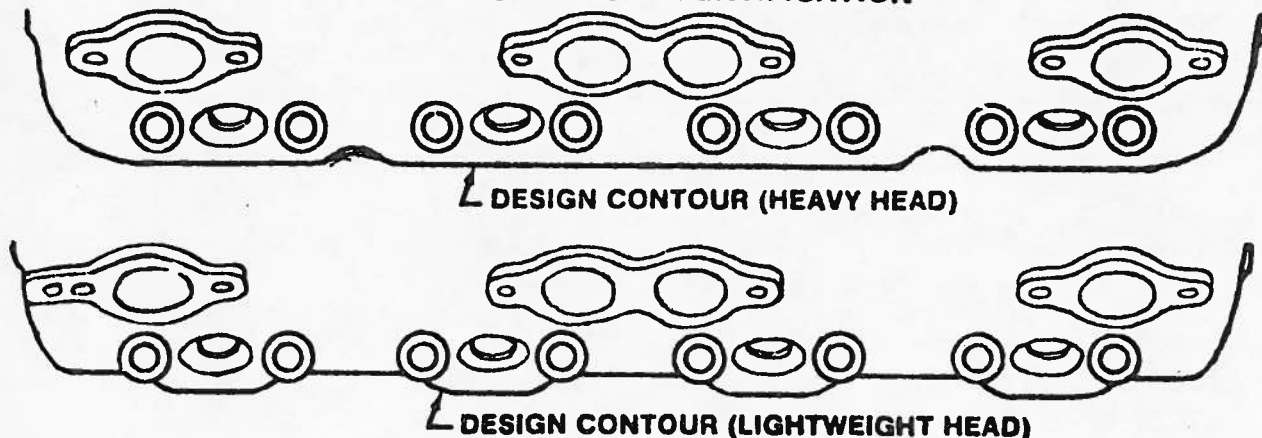
CYLINDER HEAD IDENTIFICATION

LIGHTWEIGHT HEAD - 1ST DESIGN

Exhaust valve seats are machined to "heavy" head specifications (uses 33241 valve spring assembly for inlet valve and 33312 valve spring assembly for exhaust valve).

LIGHTWEIGHT HEAD - 2ND DESIGN

Incorporates machining that allows inlet valve spring assembly (33241) to be used at both inlet and exhaust valve locations.

The cylinder heads can be identified by measuring from the top of the exhaust valve guide to valve spring seat (exhaust only).

If the dimension is .75" (3/4" or 1.91 cm), use 33312 valve spring (1st design head).

If the dimension is .84" (27/32" or 2.14 cm), use 33241 valve spring (2nd design head).

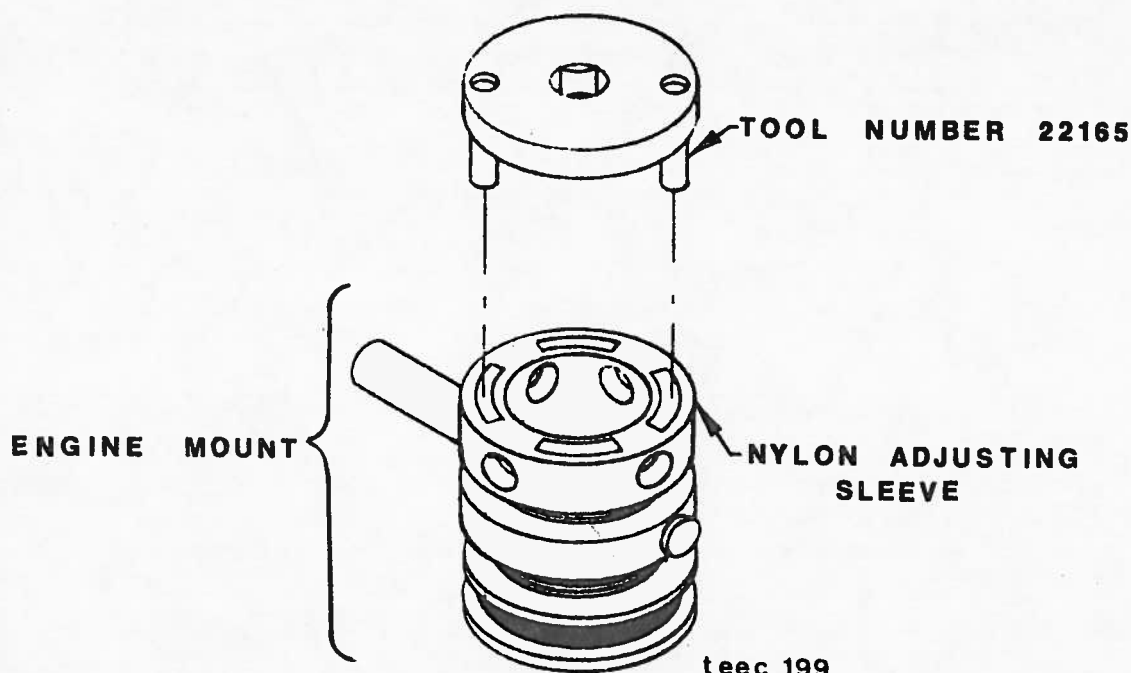
MOUNT ADJUSTING TOOL (part number 22165)..... \$14.50 net.

It has been brought to our attention that the nylon adjusting sleeve on the engine mounts have been breaking when making final engine alignment adjustments. We have found this happens most often on applications where there is not sufficient clearance to rotate the nylon sleeve with a adjustment rod incerted through "both" sides of the adjustment sleeve.

A NEW mount adjusting tool (part number 22165) is now advailable from Crusader Marine to correct this problem.

The tool is used by placing it on top of the nylon adjusting sleeve where two drive pins engage the shoulders of the sleeve. This allows the use of a ratchet wrench on applications where working room is limited.

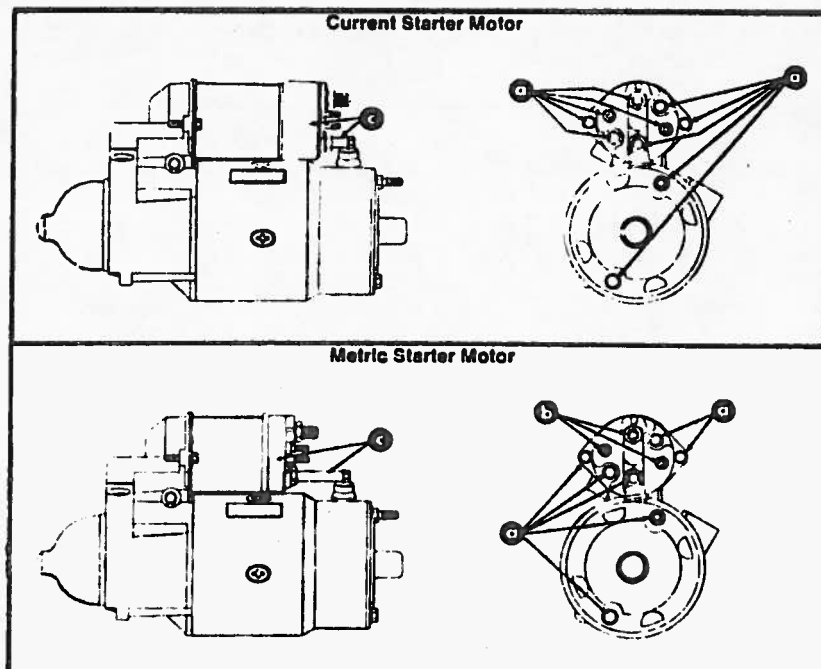
Figure 1. Delco-Remy Starter Motor Identification

a - English Thread b - Metric Thread c - Difference in Solenoid Length

All Crusader gas engines now being built are equipped with new Delco Remy "metric starter" motors which use metric fasteners and a shorter solenoid. Check the Delco number before ordering replacement parts to assure ordering correct replacement parts, as engines may be equipped with either starter motor.

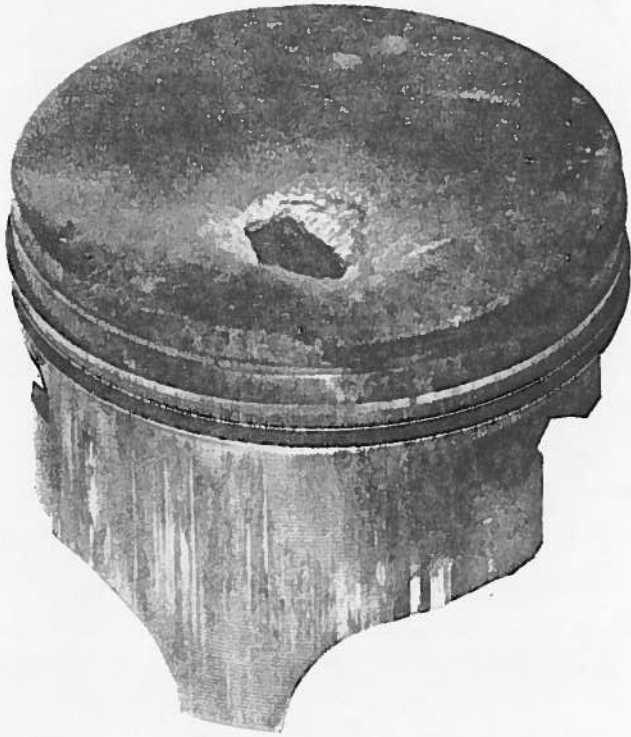
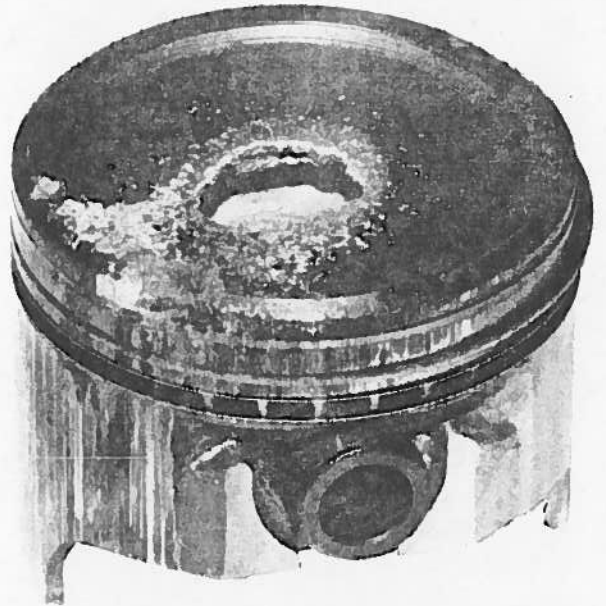
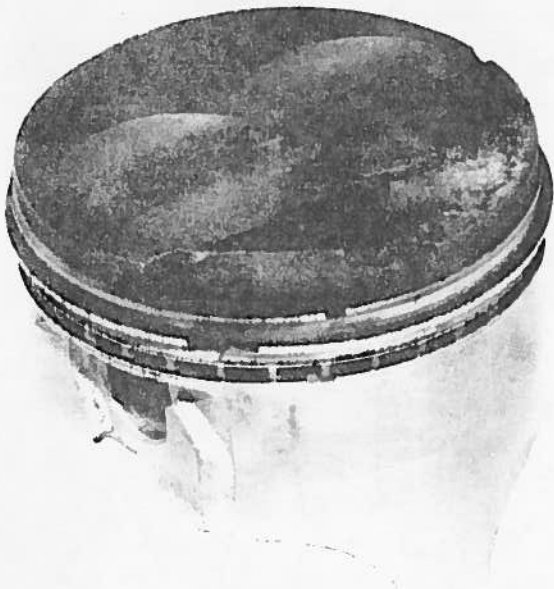
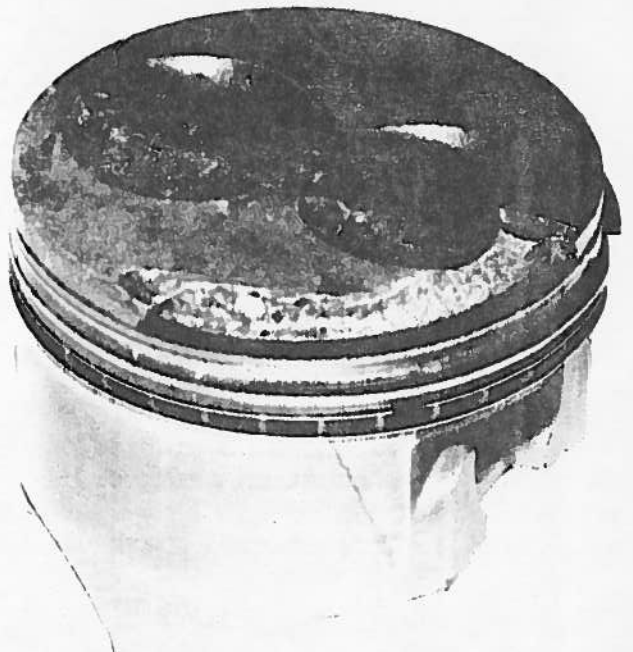
Detonation starts out as normal combustion with the spark ignited flame progressing across the combustion chamber while applying heat and pressure to the unburned portion of fuel. Then, instead of continuing to burn smoothly and evenly, the last portion of fuel explodes violently, causing overheating of spark plugs, pistons, and valves.

The use of low octane fuel is one of the most common causes of detonation. Even when using proper fuel, detonation can occur if engine maintenance is neglected. Other causes of detonation are as follows:

- 1.) Over-advanced ignition timing.
- 2.) Lean fuel mixture at or near full throttle caused by carburetor or leaking intake manifold.
- 3.) Inadequate cooling of engine by deterioration of cooling system.
- 4.) Excess accumulation of deposits on piston and/or combustion chamber.
- 5.) Cross-firing spark plugs.
- 6.) Improper engine RPM at wide open throttle.

The accompanying photos show the type of piston damage caused by detonation.

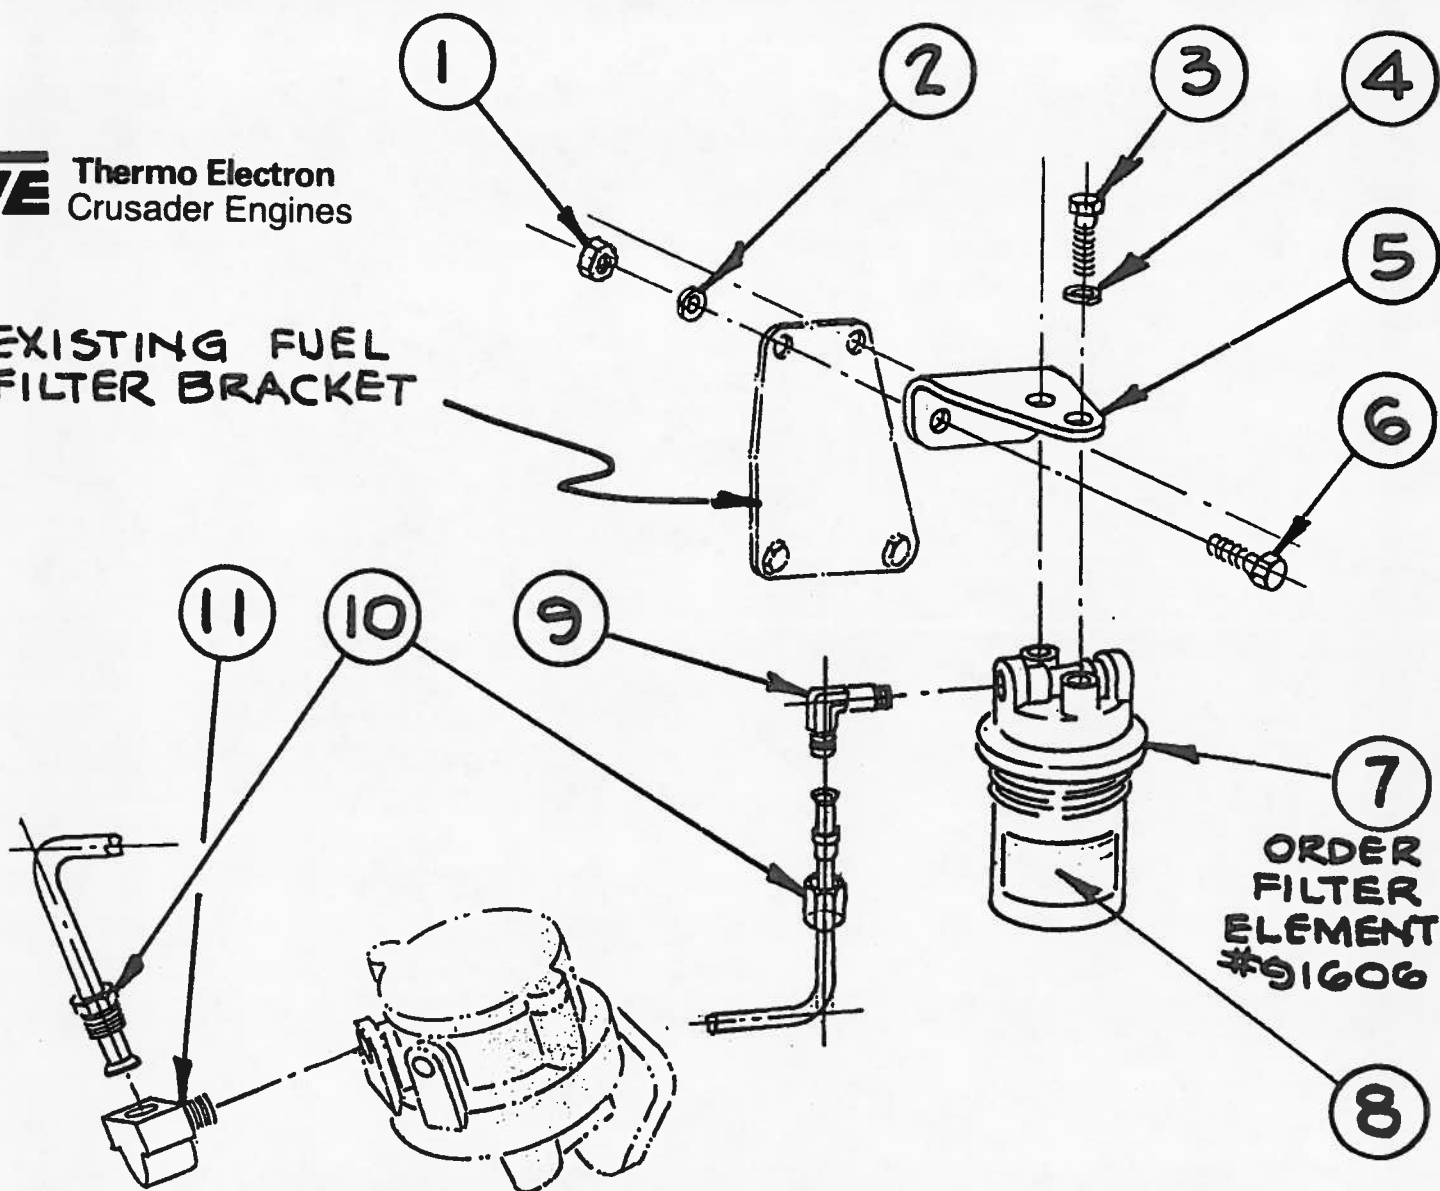
**A-C FUEL FILTER CONVERSION KIT #22378
FOR 229 C.I.D. V-6 ENGINE - MODEL 165**

In some engine applications it has been found that the standard fuel filter has not performed up to specification, thus allowing certain types of foreign material to pass through to the carb filter and cause a fuel restriction, leading to poor idling and/or loss of W.O.T. operation. This material is silicones, waxes and strands of glass used in the construction of fiberglass boats and most notably, fiberglass fuel tanks.

When dealer service people are checking out the above complaint, they are finding the bronze filter in the carb restricted. In that they can't see any foreign material on the filter, it is then mistakenly thought the problem is the bronze filter itself and therefore removed and not replaced. This is IMPROPER! In these applications the bronze filter is working and catching the material which is passing unrestricted through the primary filter.

To correct this problem a fuel filter conversion kit has been developed to replace the original filter. The kit consists of new fuel filter assembly, fuel line and filter bracket. The new filter will catch the material used in fiberglass production.
