Engine Division

SUBJECT: Prestolite Distributor Housing - Excessive Moisture
and Rust Build-Up

MODEL(S) AFFECTED: All V-8 Gasoline Engines

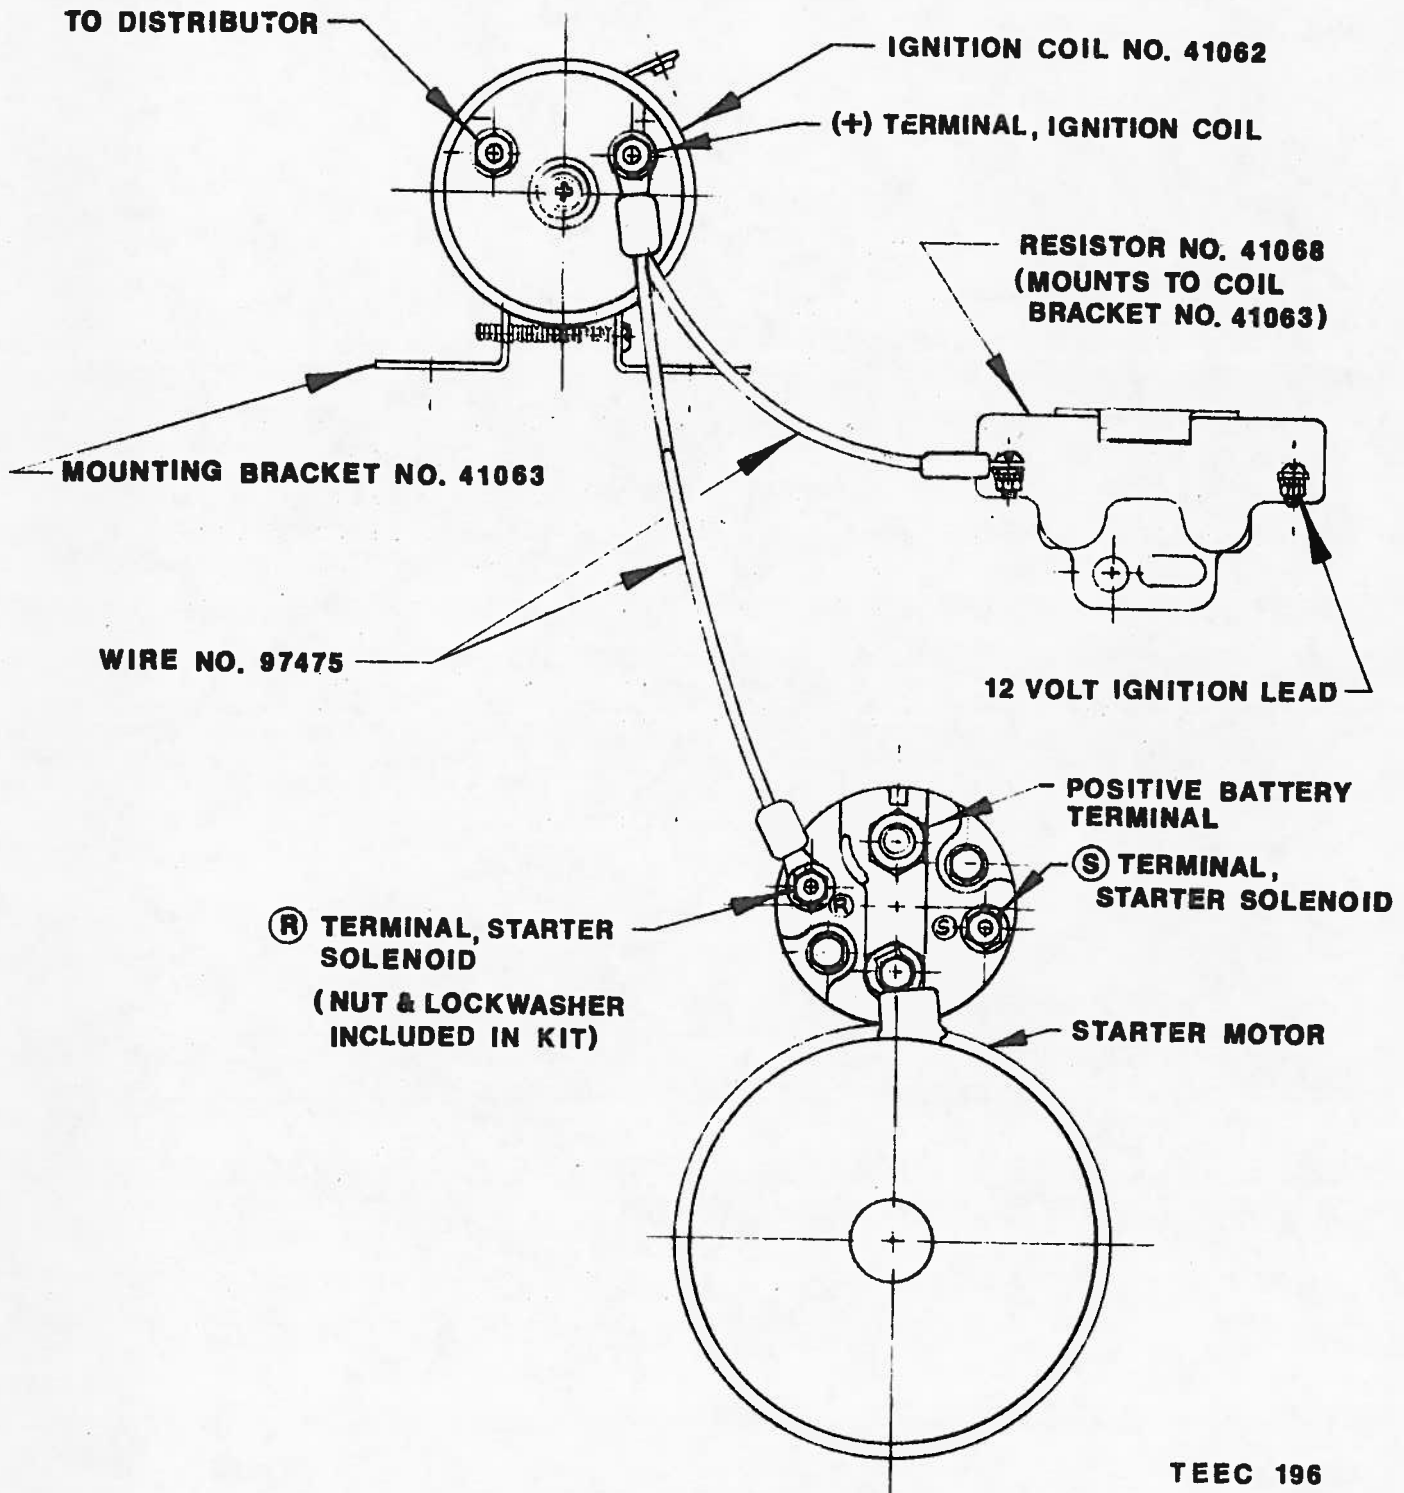
INSTALLATION OF COIL CONVERSION KIT NO. 22308

We have noticed some confusion about the availability of the Delco ignition coil, part no. 91412. This coil is no longer available from Crusader Marine. In order to improve engine starting performance we have replaced the 91412 ignition coil with coil conversion kit part no. 22308. The new kit uses a external resistor with a ignition bypass wire from the starter solenoid directly to the coil to deliver a higher voltage in the starting mode only. The kit includes a new style coil with external resistor and all necessary mounting hardware to install on the affected engine.

This kit will replace all Delco ignition coil assemblies. It is further suggested that the complete ignition system be checked and engine tuned-up if needed to further protect against engine starting failure.

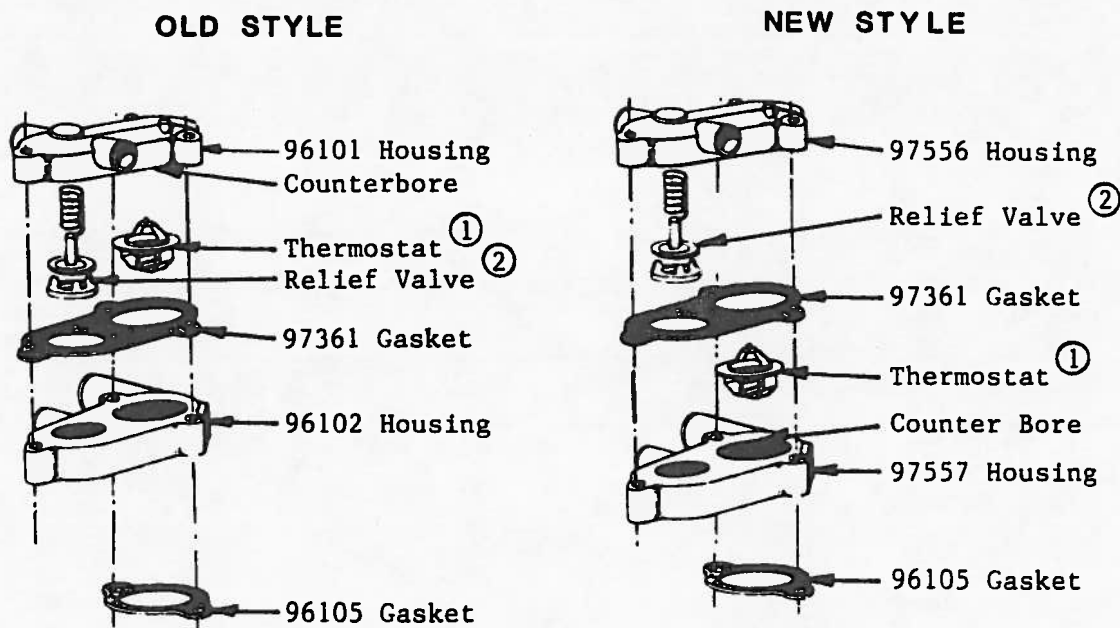
Figure 1

To make installation of the thermostat easier the counterbore for locating the thermostat assembly has been moved from the upper cover to the lower thermostat housing. Whenever replacing one of these components, it is important that the correct housing be installed to insure proper thermostat location as old and new style housings are not interchangeable and must be serviced with correct thermostat top cover. To identify which style is on engine, visually check location of the thermostat counterbore and order the correct replacement part shown below:
